Coffee Can Saddle Tree Strike Learning Review Narrative

August 2024

Summary

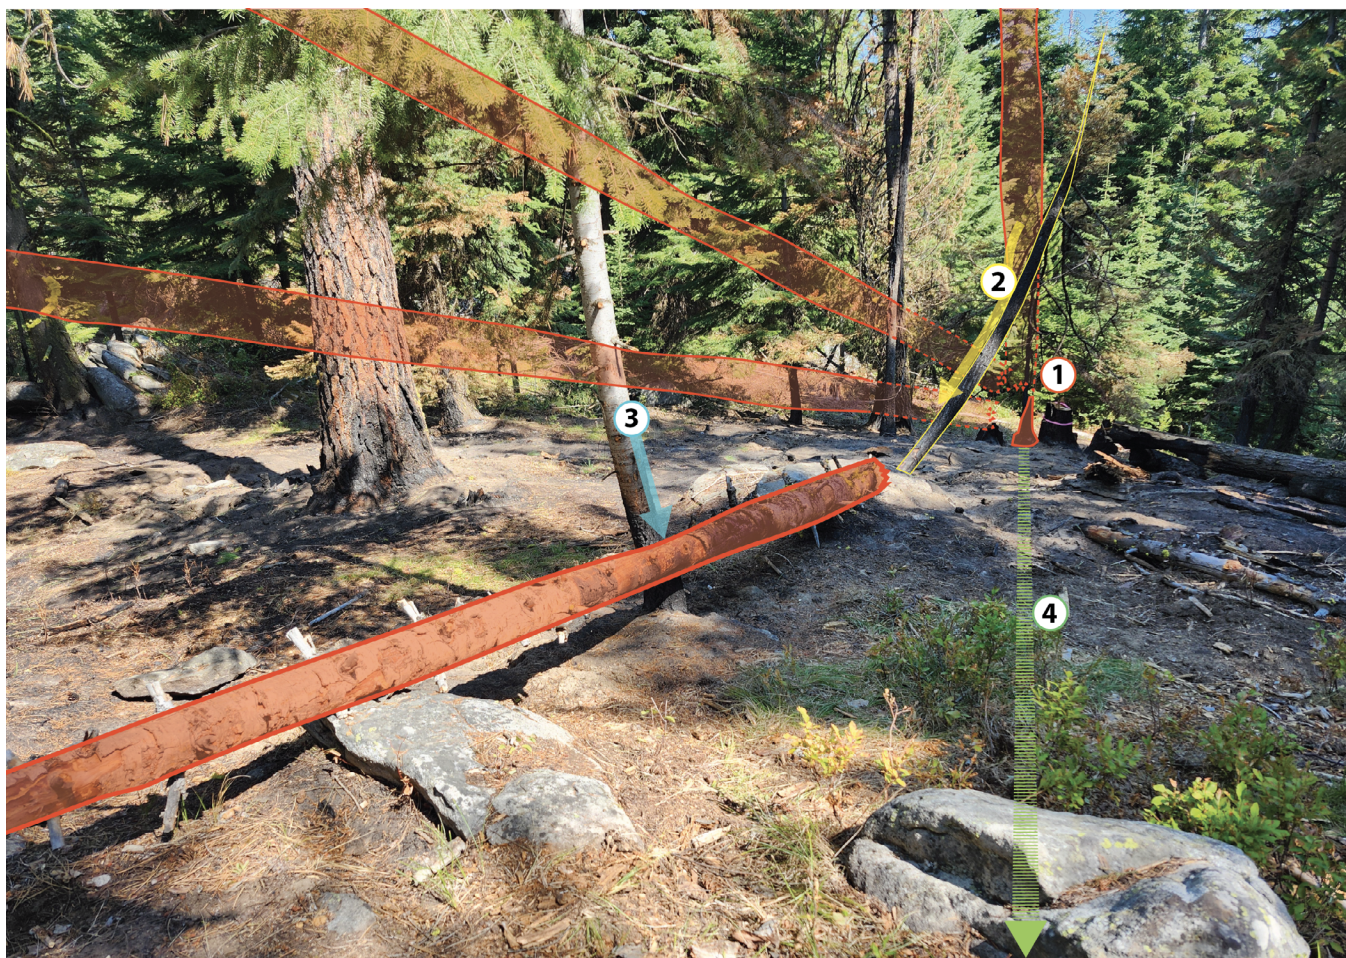
The strike tree was a standing, dead (snag) subalpine fir that was approximately 70–80 feet tall, and approximately 15 inches diameter at breast height (DBH). ENG-1 (IC) was struck by the top 1/3 of the tree, where the diameter was approximately 6–7 inches.

Photo 1.— (1) The strike tree stump and original position. (1a) indicates the lean of the tree. The tree fell and struck a small live tree (2), causing it to pivot to the right. The strike tree came to rest against another live tree (3). (4) indicates approximately where the tree impacted the ICT5. The tree was originally suspended about 5 ft above the ground.

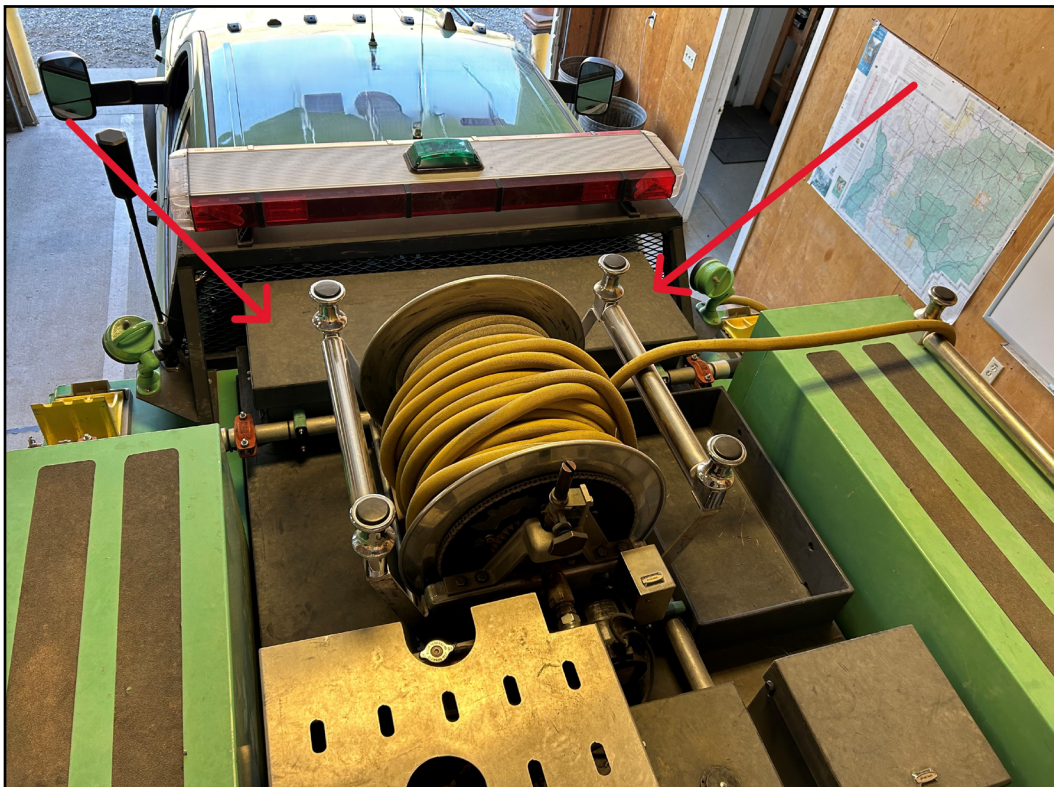
SMJ-4 was sent down the hill to the engine to bring up some medical equipment. He searched, but “after searching through all the compartments, the cab, and the gear stored on top, I was unable to find any of the stuff they wanted.”

Photo 2.—The red arrows point to the black box where the requested trauma bag was located, there was no SKED. The only way to access the box is to climb on top of the engine.

- The obvious lesson from this incident for the participants was the importance of knowing the location of medical equipment on vehicles, especially when someone from another module is asked to retrieve gear. Compartment doors should be marked with First Aid/Medical decals that clearly display their location.

- The engine module has remedied this by labeling the locations of medical equipment on all their vehicles.
- Standardizing the location of medical equipment on crew vehicles emerged as a possible lesson in both the interviews and in the facilitated dialogue. It was felt that while this might work well at a unit/district level, it is unrealistic at the larger interagency levels. Since standardization was not seen by this group as viable, they came back to the importance of labeling the location of medical equipment as the principal lesson.

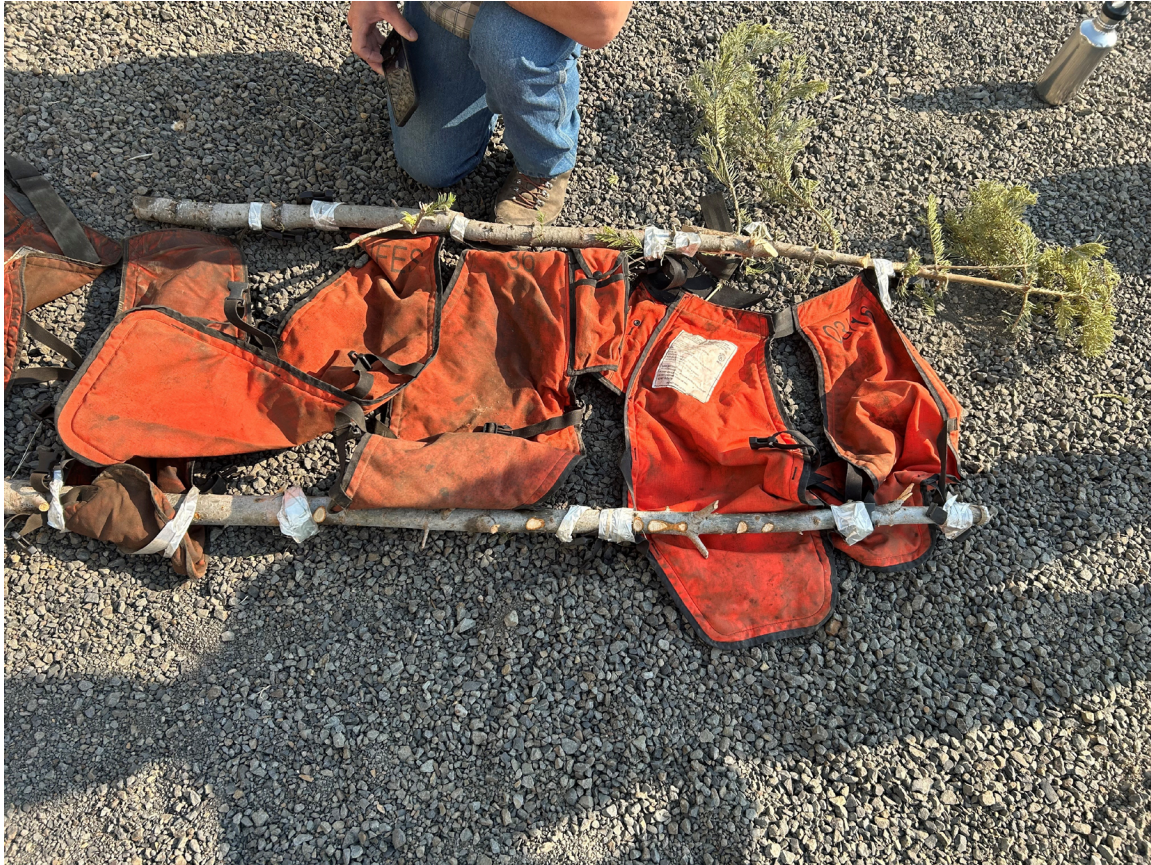
Photo 4.—*The actual improvised litter made with 3 pairs of chaps, fiber tape, and small trees cut and limbed.*
