Coffee Can Saddle Tree Strike Learning Review Narrative

August 2024

Summary

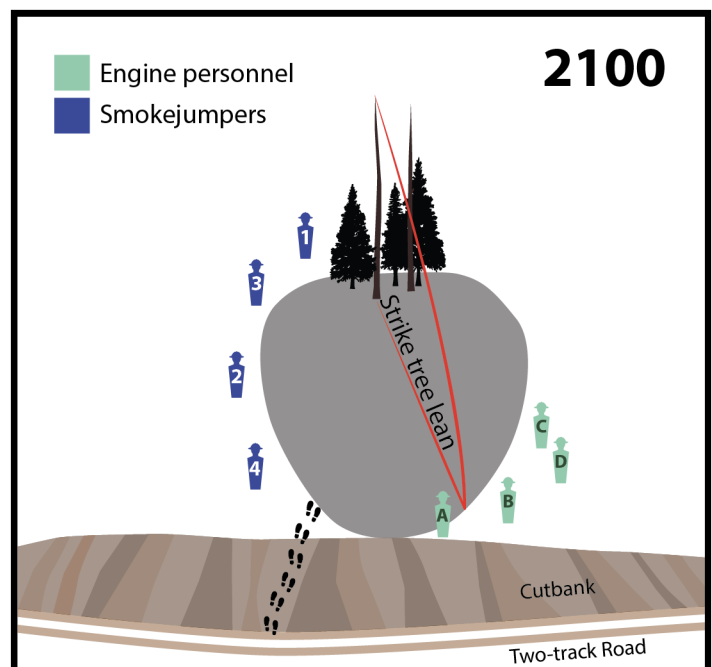
Near the head of the fire, SMJ-1 noticed two snags close to the edge, a few feet into the black, and leaning interior and back towards the right flank. At least one of the snags appeared to have substantial fire damage and he thought it could fall soon. SMJ-1 radioed the other jumpers on the smokejumper crew frequency to let them know about the snags, and that they had potential to fall before long. SMJ-2 later recalled that, "Upon hearing that traffic, I stopped digging line and moved up the right flank, taking note of both snags while making my way towards the head." SMJ-2 tied in with SMJ-1 and, once again, began to build line near the head of the fire, away from where the snags were leaning.

Figure 4.—At approximately 2100, all smokejumpers were on scene, with one smokejumper at the head of the fire who noticed two snags burning. The engine crew also arrived and were establishing a game plan to suppress the fire with the smokejumpers. The engine crew was to anchor to the right, with jumpers to the left.

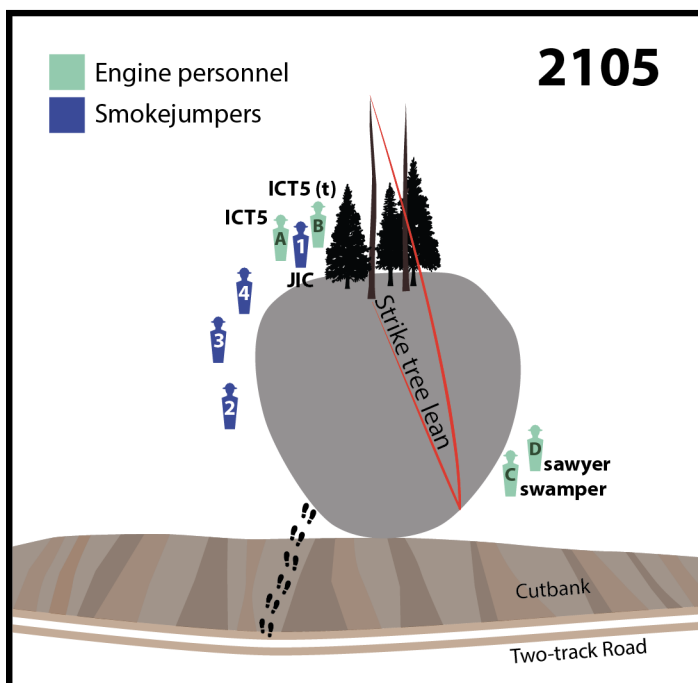
Figure 5.—At approximately 2105, the engine crew had a sawyer and swamper cutting on the right flank. ENG-1 walked around to the head of the fire with ENG-2 to tie in with the JIC (jumper in charge). Hazard tree information was communicated between one another, and a plan was made to suppress the fire.

perimeter to see the rest of it before calling in the size up report to dispatch. On his way past the clump of trees—he thought there could be anywhere from 2–5 trees in the clump, some alive and some dead—ENG-2 noted a larger dead snag that was burning at the base. With the aid of his headlamp, ENG-2 got an idea of its height. His overall impression was, "there were snags on this fire, just like every fire we are on," and the snag burning at the base, "still had some meat to it." After finishing his lap around the fire, ENG-2 tied in with ENG-1 on the right flank, near the heel, to go over the size up information that would be provided to dispatch. ENG-2 briefly talked with the saw team to confirm that they were responsible for putting line in towards the head on the right flank.

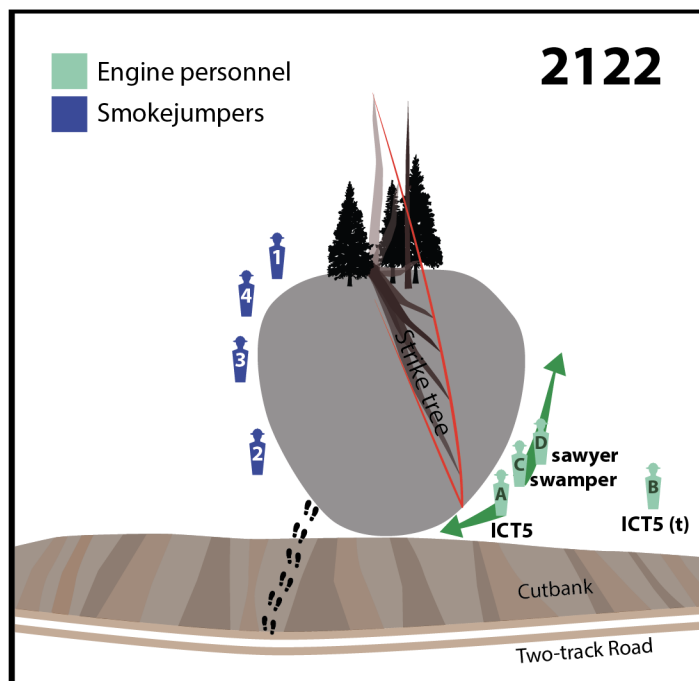
Figure 6.—ENG-1 made their way through the black to tie in with the engine crew's saw team. ENG-2 walked around the head, towards the right flank, then went away from the fire to call dispatch. A jumper heard the tree starting to crack and yelled out. The sawyer and swamper moved to the right, while ENG-1 moved to the left and was hit by the tree.

near the head, he heard the burned-out snag "starting to crack and groan." He saw the tree falling towards four headlamps on the right flank, and began yelling as loud as he could, "TREE COMING DOWN! LOOKOUT!"

slightly to look up at the falling snag as it struck him, at 2122, just five minutes after the full size up was given to dispatch.

The strike tree was a standing, dead (snag) subalpine fir that was approximately 70–80 feet tall, and approximately 15 inches diameter at breast height (DBH). ENG-1 (IC) was struck by the top 1/3 of the tree, where the diameter was approximately 6–7 inches.
